Facilities Assessment Report

December 2001

3D/International

In preparation for a Spring 2002 bond issue, Chaffey Community College District retained 3D/International to assist the District in assessing and documenting the facility repair, rehabilitation, modernization and new construction requirements for its Chaffey campus and satellite facilities.

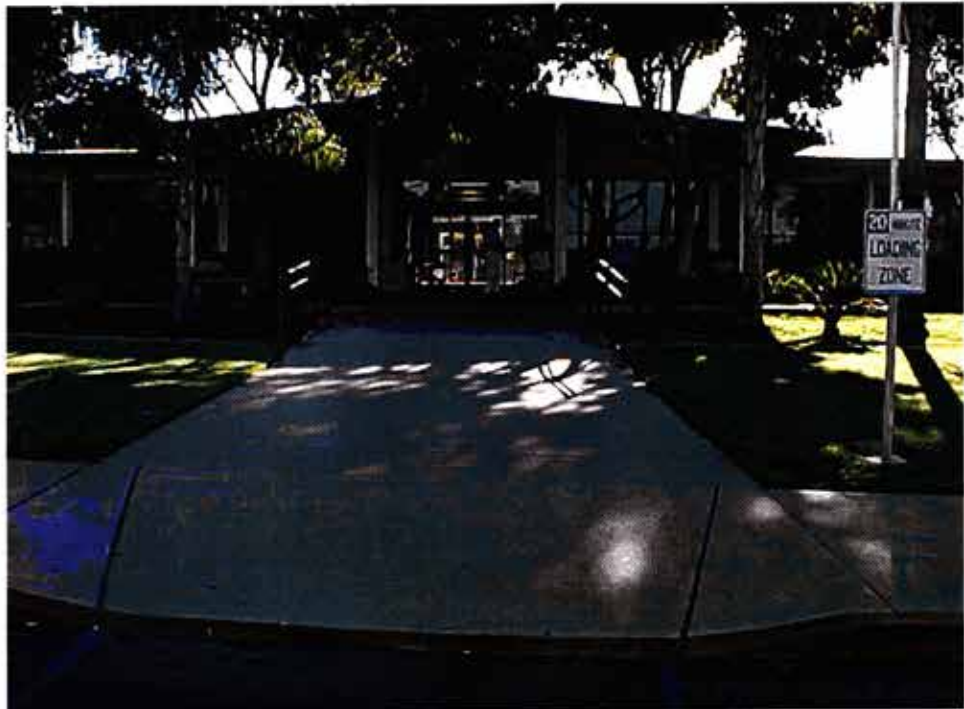
Main Campus - Administration

The Administration Building is located at the west end of the campus. It is a one (1) story building with about 17,000 sf. It was built in 1959 and upgraded in 1970. Many of the systems are past their useful life and need to be replaced.

The construction of this facility is concrete with brick and plaster in fill. The foundation is spread footing with slab on grade floor. There are no signs of settlement. The interior is wood frame with painted plaster skin. The floors are tile or carpet, the ceilings drop frame.

The roof was last replaced in 2001 with an APOC system and is not experiencing any leaks.

MECHANICAL-The chiller and cooling tower were replaced in 1995 along with an upgrade of the energy management system to DDC from pneumatic. The air distribution devices and ductwork were partially replaced in the admission/records remodel of the building. The air handling units, boiler, and piping date from the original construction. The original pipe insulation at the fittings contains asbestos and will need to be replaced when the piping is replaced. The boiler is scheduled for replacement in the near future. Although the air handling unit is original, it has been well maintained and serves the intended purpose.

FCI:
25.77%

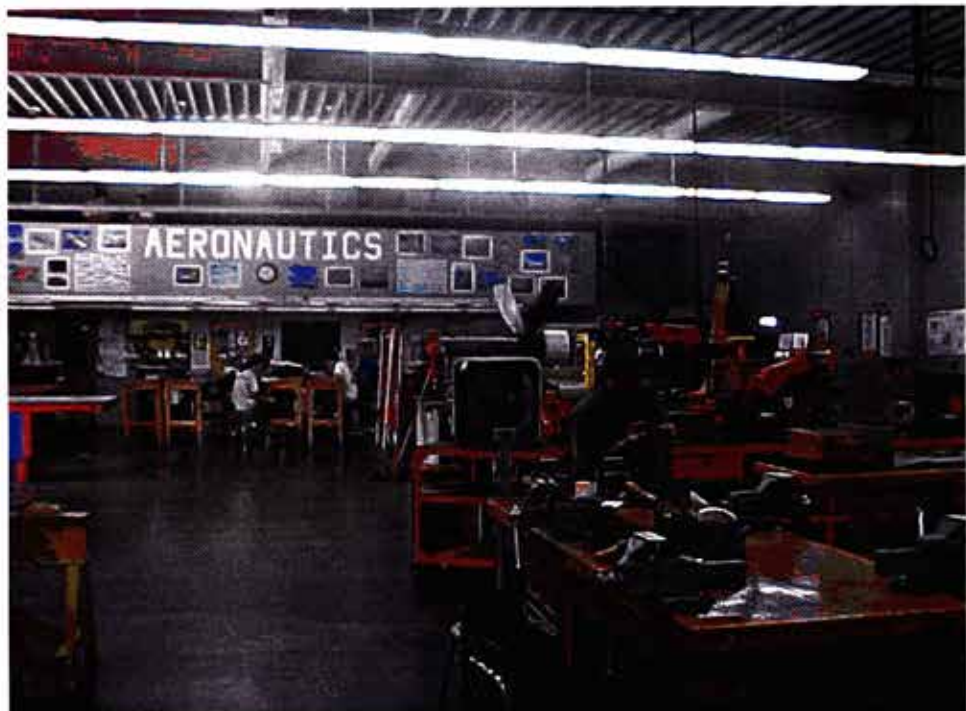
Main Campus - Aeronautics

The roof was last replaced in 2001 with an APOC system and is not experiencing any leaks.

FCI:
13.36%

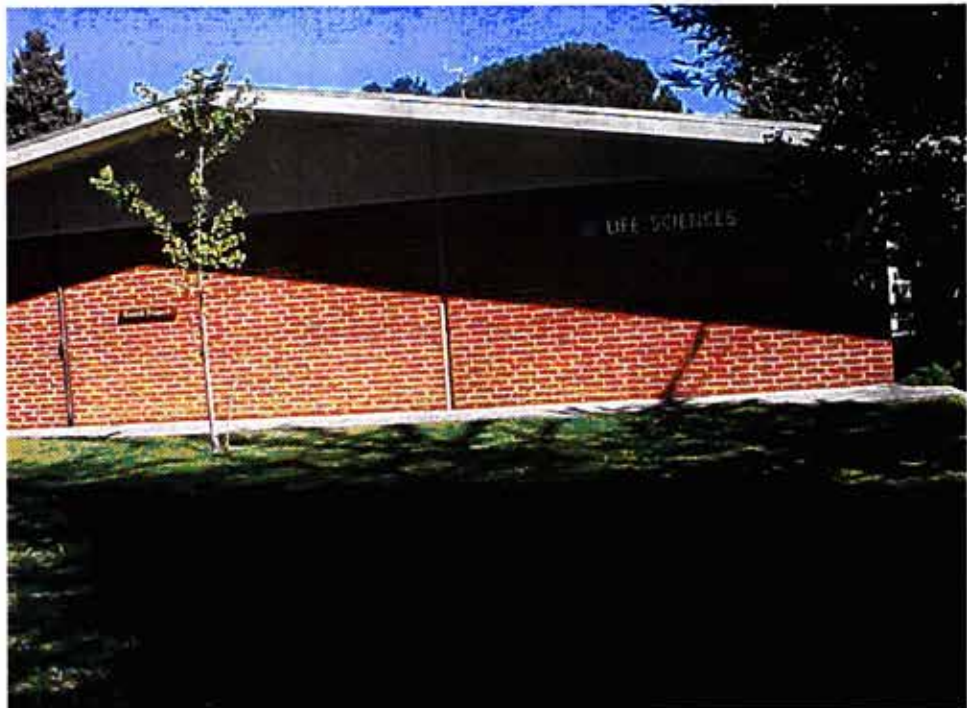
Main Campus - Life Science East

FCI:
57.88%

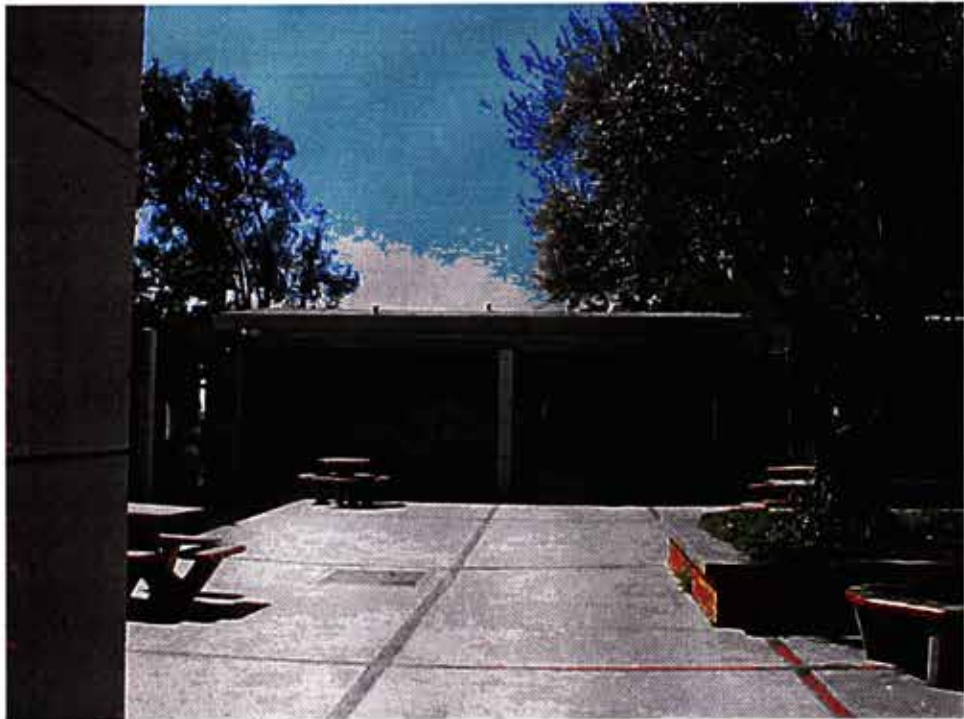
Main Campus - Art

FCI:
12.68%

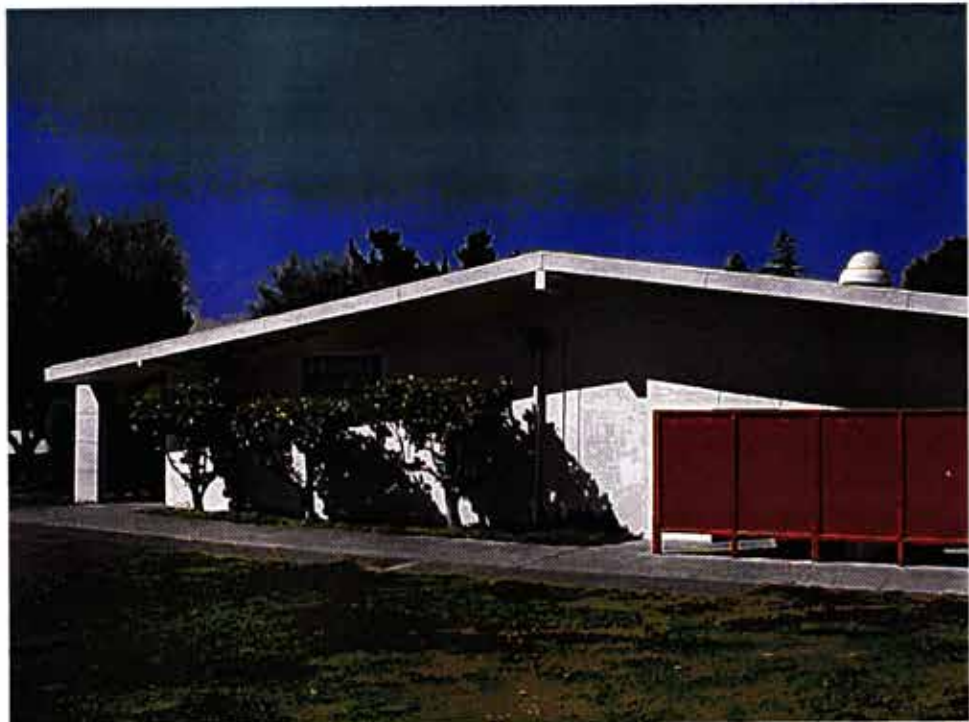
Main Campus - Business Education

FCI:
4.53%

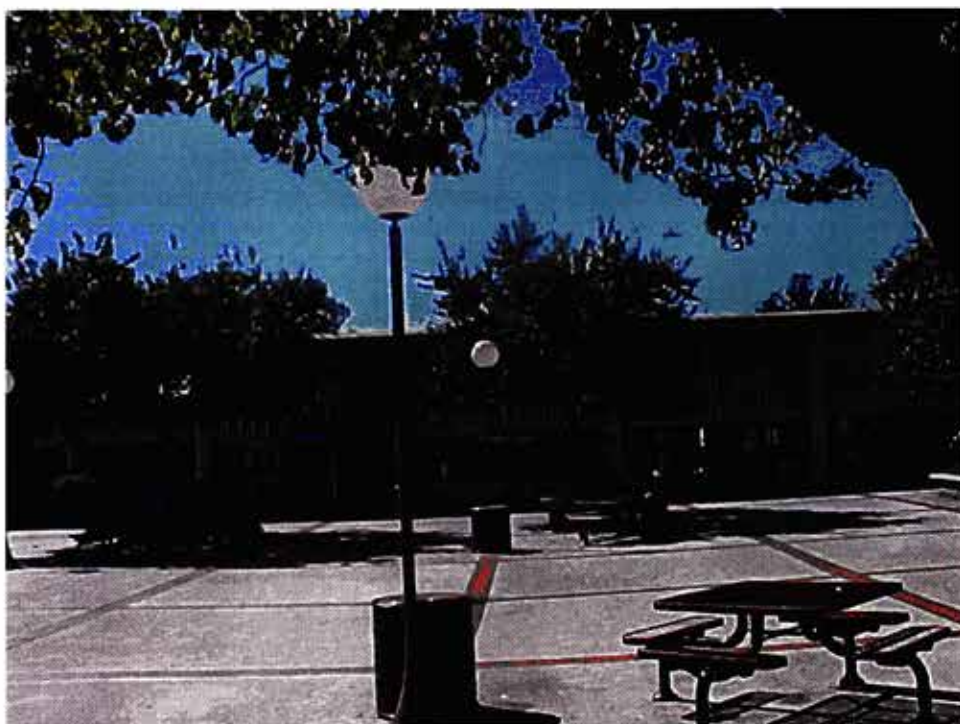
Main Campus - Campus Center West

FCI:
6.21%

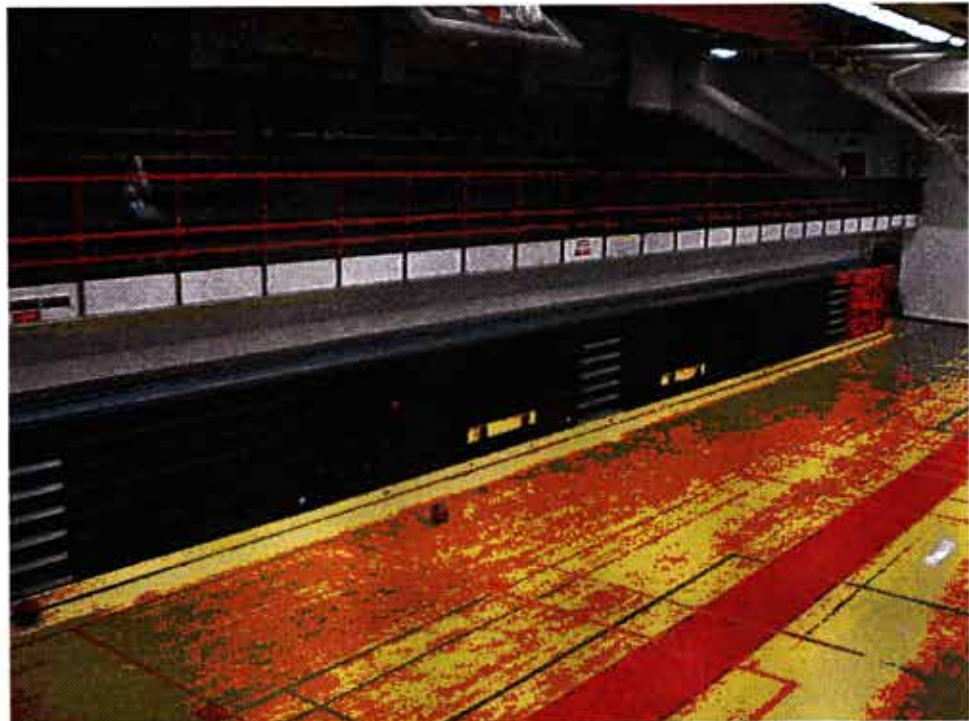
Main Campus - Gymnasium and Athletic Center

FCI:
17.44%

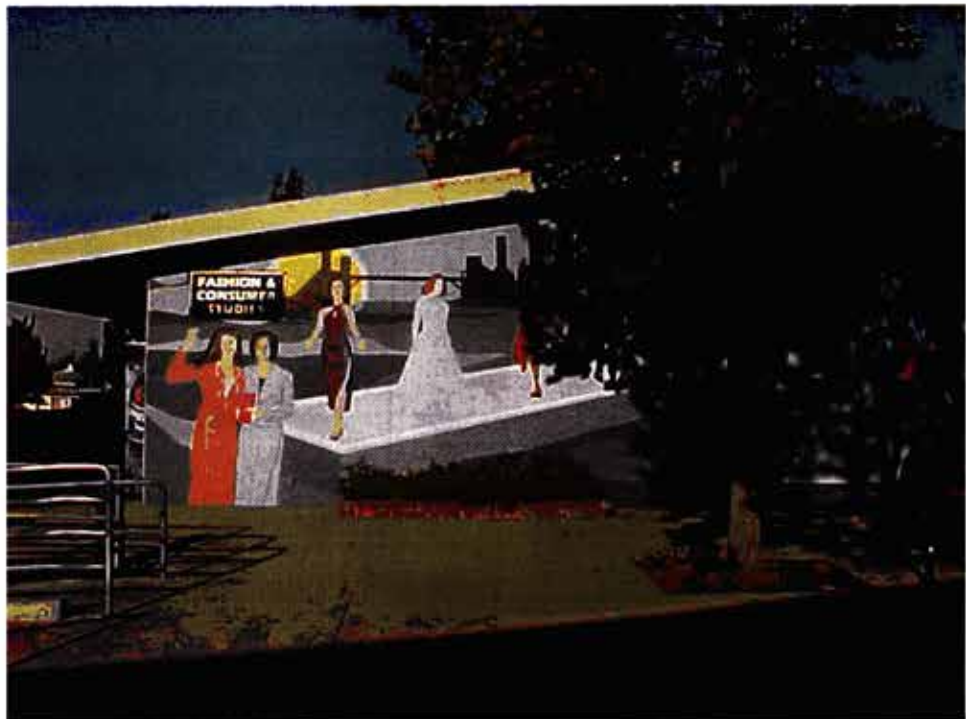
Main Campus - Home Econ.-Fashion & Consumer

FCI:
30.67%

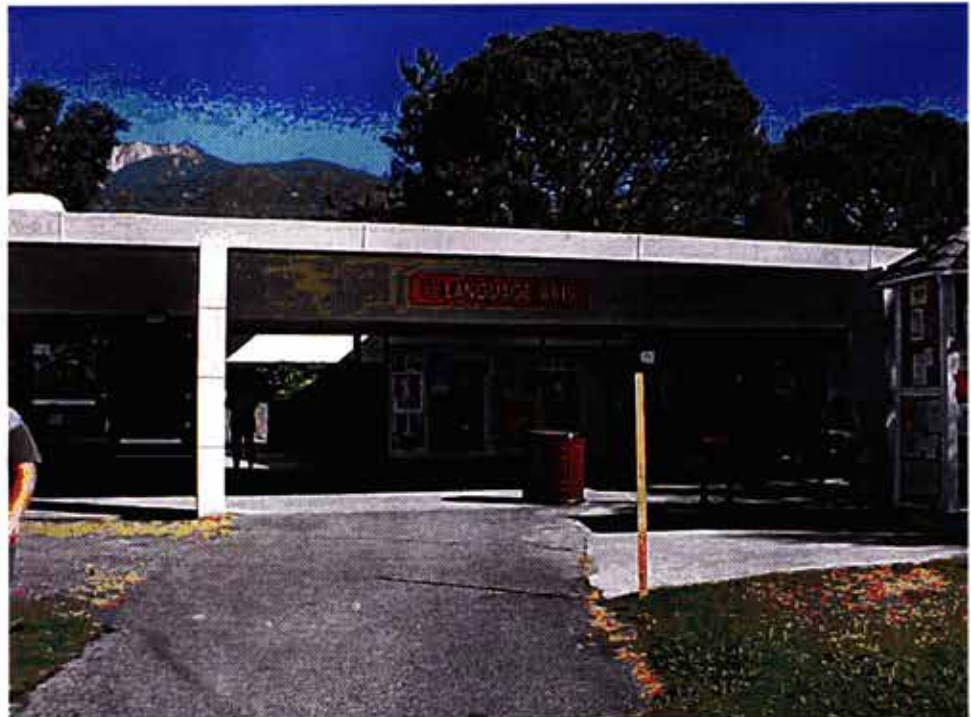
Main Campus - Language Arts

FCI:
8.68%

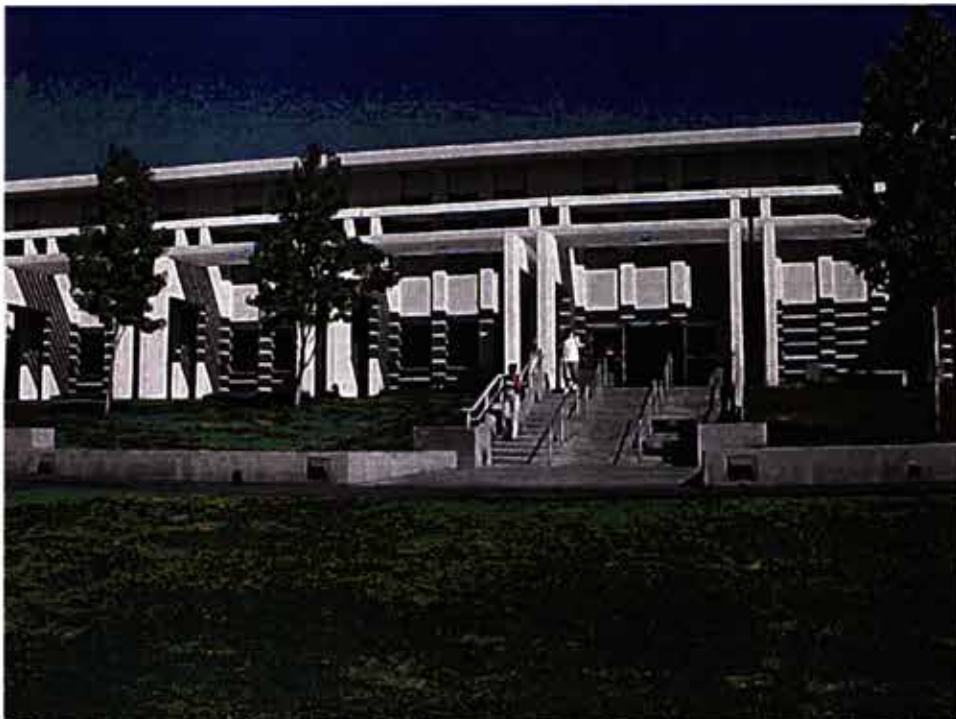
Main Campus - Library

17.46%

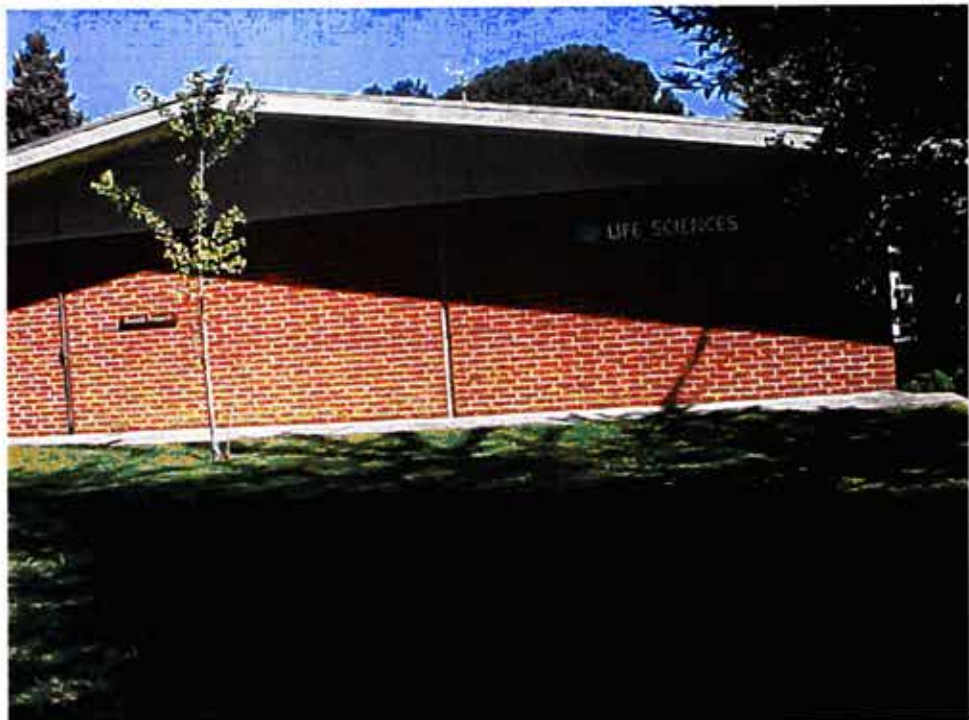
Main Campus - Life Science West

56.51%

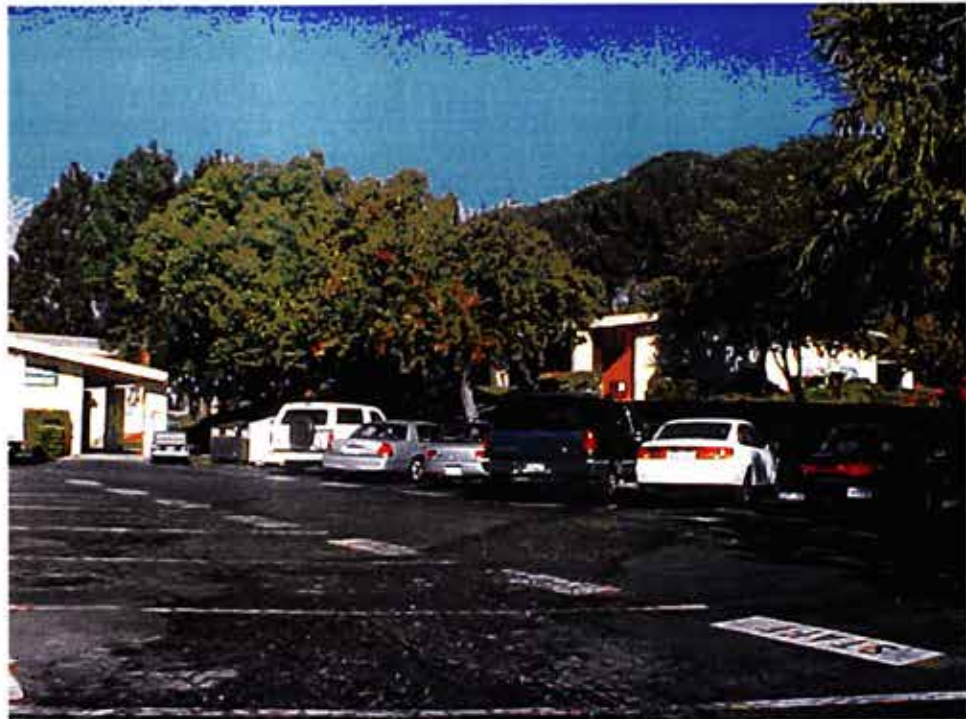
Main Campus - Physical Science

FCI:
36.29%

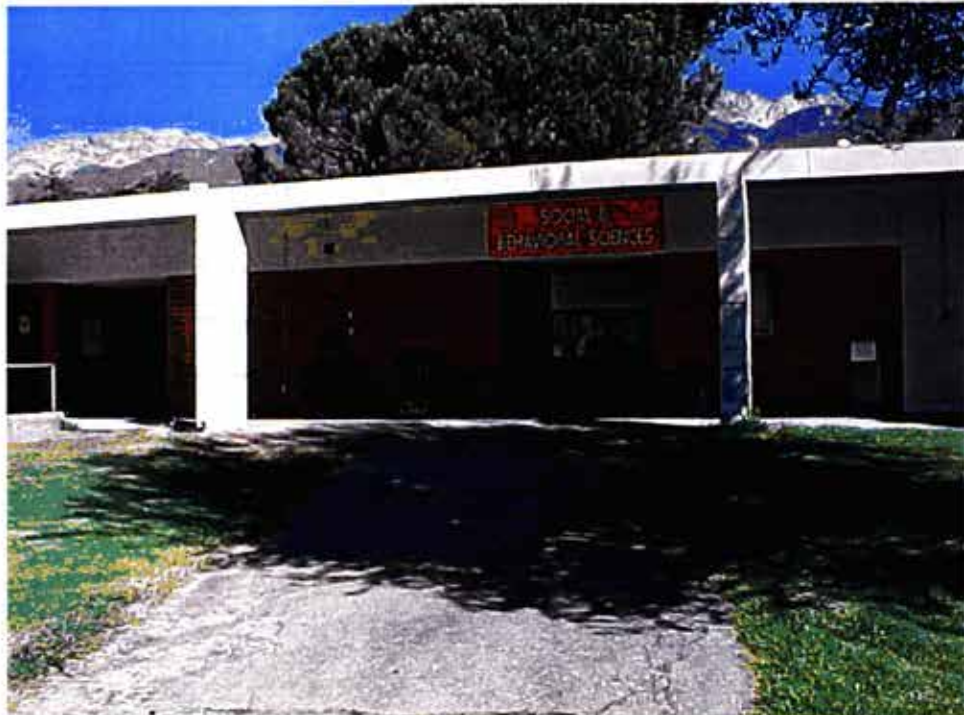
Main Campus - Social Science

8.51%

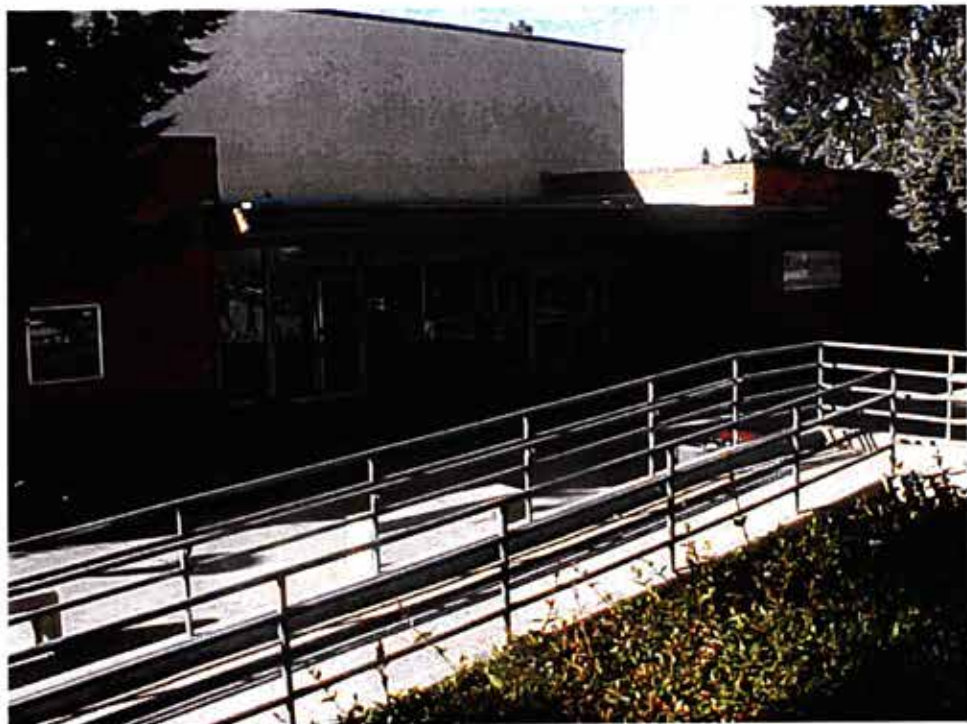
Main Campus - Theatre

FCI:
18.36%

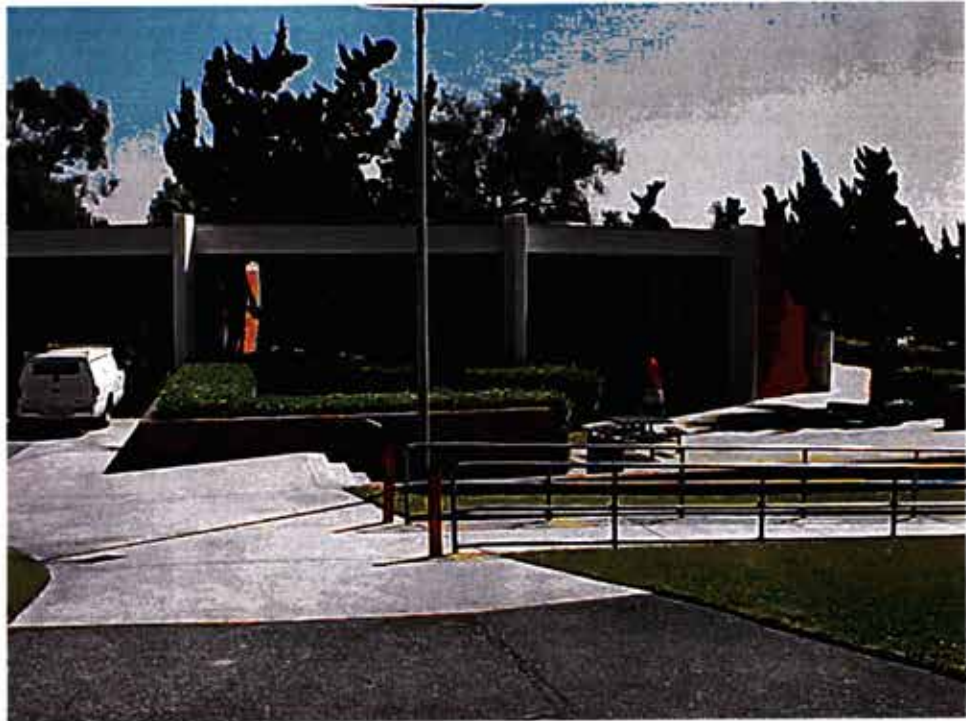
Main Campus - Wargin Hall

FCI:
46.89%

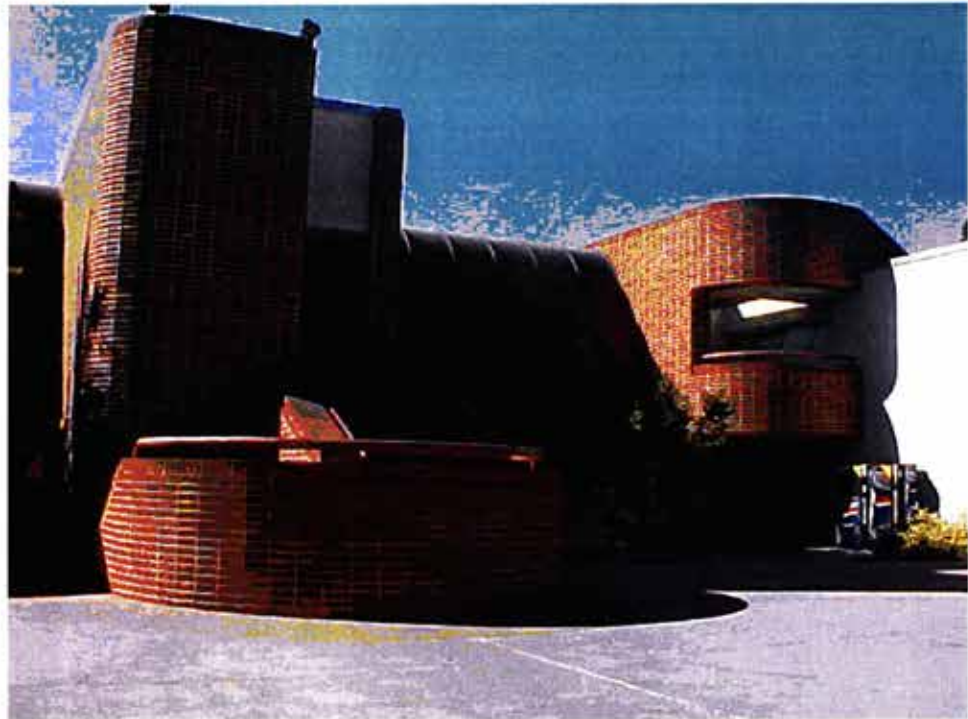
Main Campus - Vocational Education

11.12%

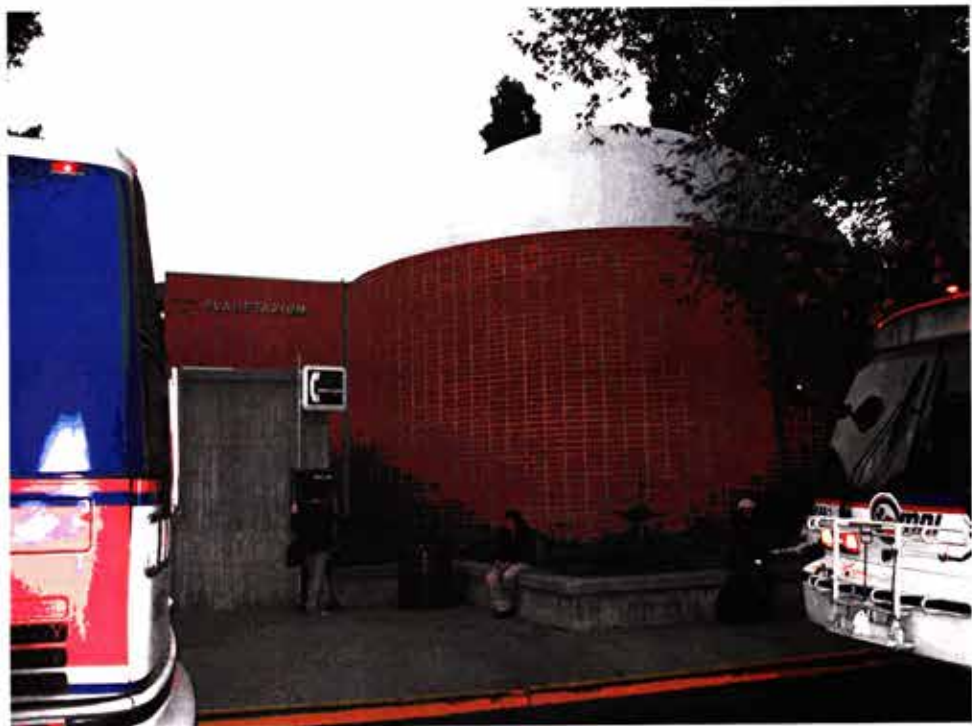
Main Campus - Planetarium

FCI:
13.37%

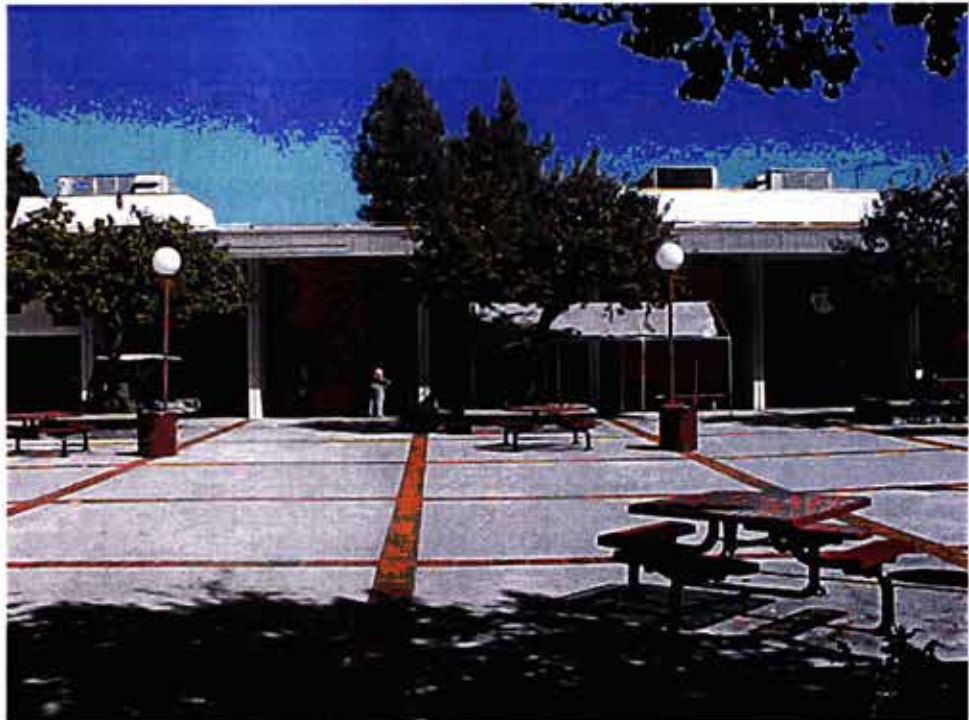
Main Campus - Campus Center East

9.12%

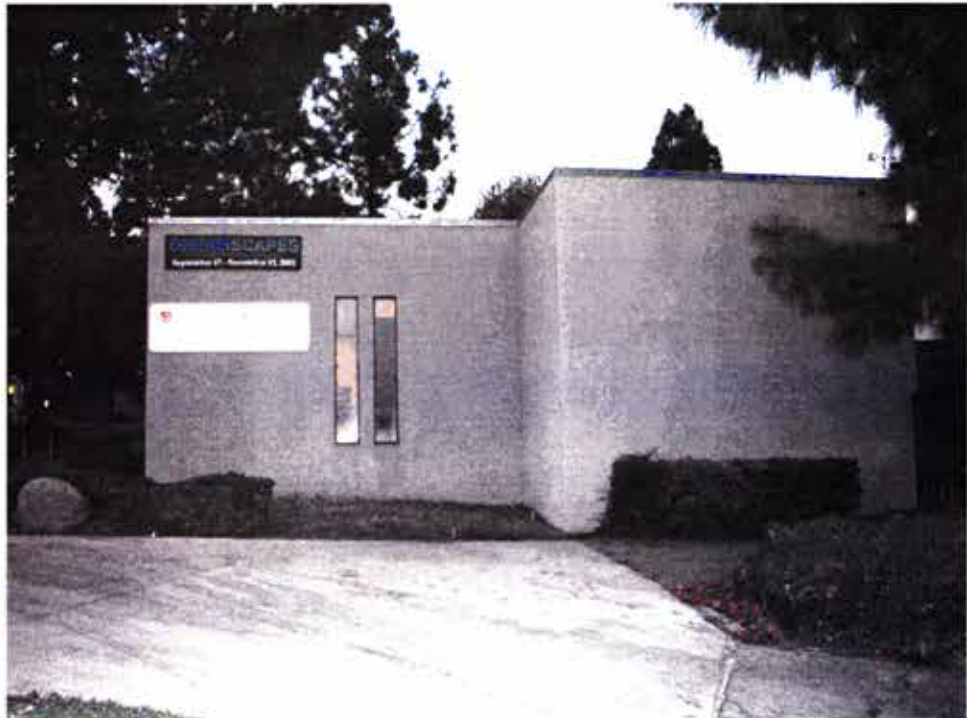
Main Campus - Museum Gallery

FCI:
5.81%

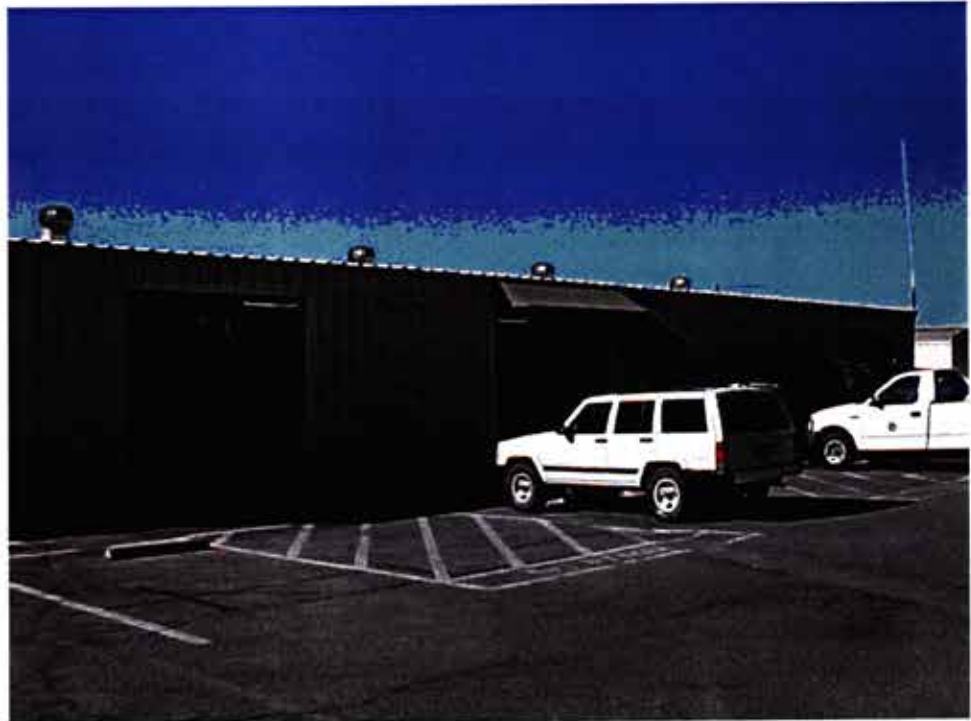
Main Campus - Warehouse

FCI:
5.86%

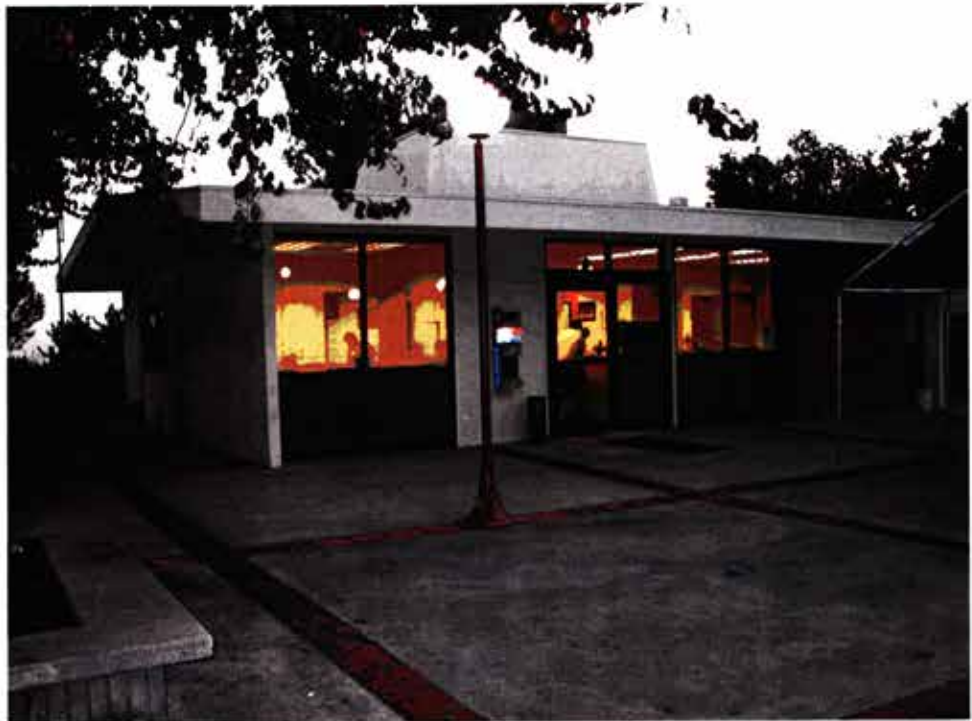
Main Campus - Public Safety

FCI:
19.69%

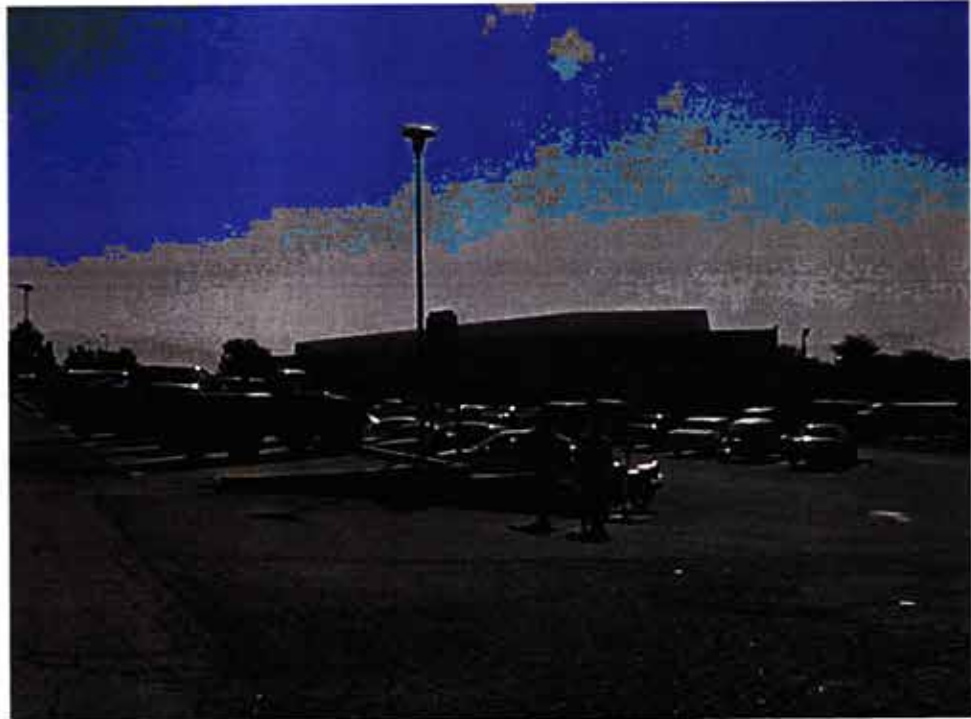
Main Campus - Auto Tech Lab

FCI:
12.41%

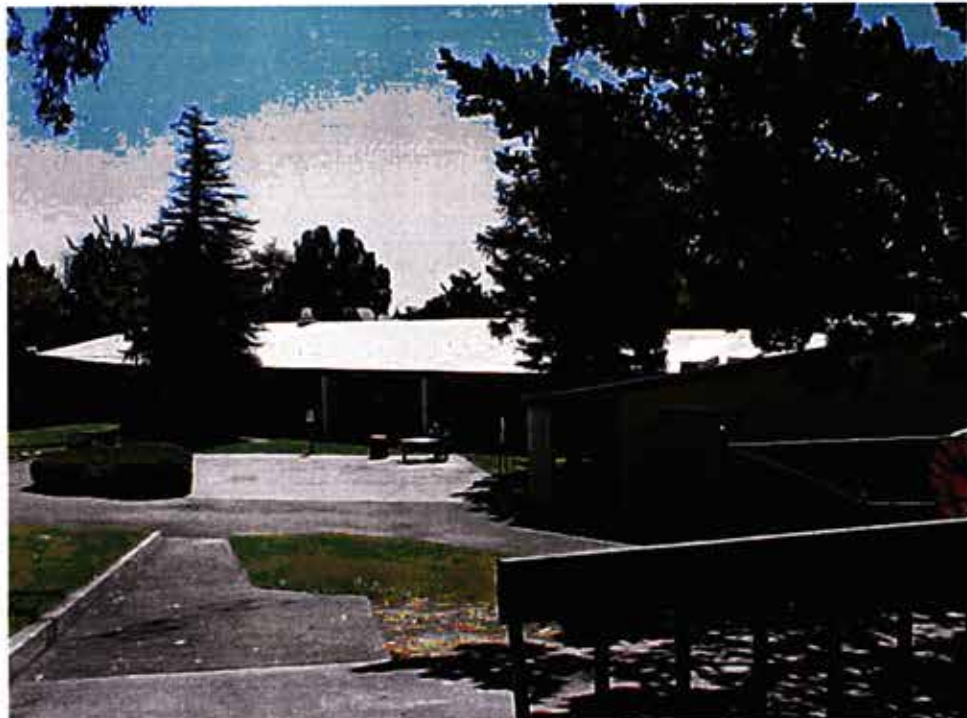
Main Campus - Health Science

FCI:
16.94%
